# Manhole Inspection Summary

Manhole # S35A\_\_020MH

Insp Date: **8/21/08 10:53 AM**

**Location** Address: **210 guilford ave**

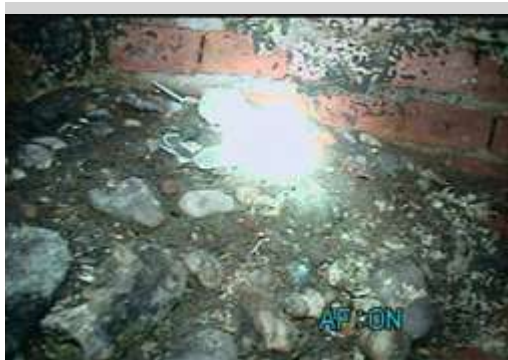
Defect 2

Condition: ☒ Sound ☐ Cracked ☐ Root Intrusion ☐ Deteriorated ☐ Leaks ☐ Debris

bench debris

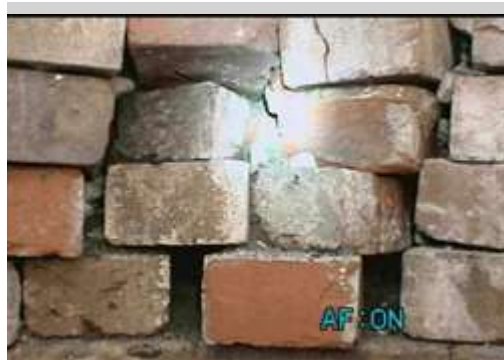
Defect 1

Condition: ☐ Sound ☐ Cracked ☐ Root Intrusion ☒ Loose Brick ☒ Deteriorated

chimney cond loose bricks, deteriorated

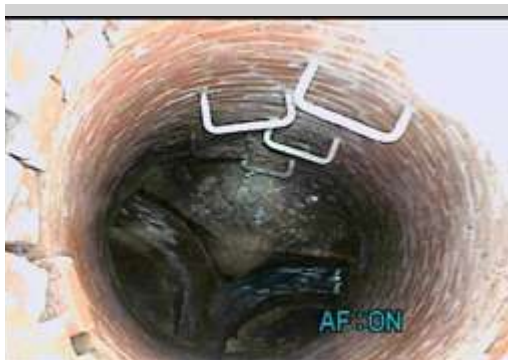
Count: **5** Missing: **0** ☒ Corroded

steps

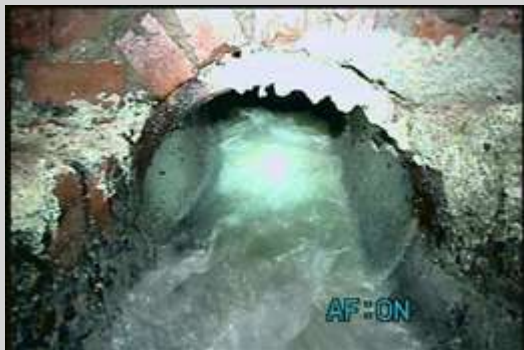
12 O'Clock Outflow

10 in. Circular Gravity Sewer  
Pipe Out @ 12 O'Clock

Deposits: ☐ None ☐ Mud ☐ Sludge ☒ **Debris** ☐ Grease

Silt Depth: 3 (in.) Deposits Extent: **Light**
